**LETTER REPORT**  
**DDD ANTHRAX FACILITY SITE**  
**INDIANAPOLIS, MARION COUNTY, INDIANA**

TDD No.:	S05-0110-018
Date Prepared:	March 14, 2002
Contract No.:	68-W-00-129
Prepared by:	Tetra Tech EM Inc.
START Project Manager:	John Sherrard
Telephone No.:	(513) 564-8343
U.S. EPA On-Scene Coordinator:	Steve Renninger
Telephone No.:	(513) 569-7539

**Subject: Letter Report  
DDD Anthrax Facility Site  
Indianapolis, Marion County, Indiana  
Technical Direction Document No. S05-0110-018  
Tetra Tech Contract No. 68-W-00-129**

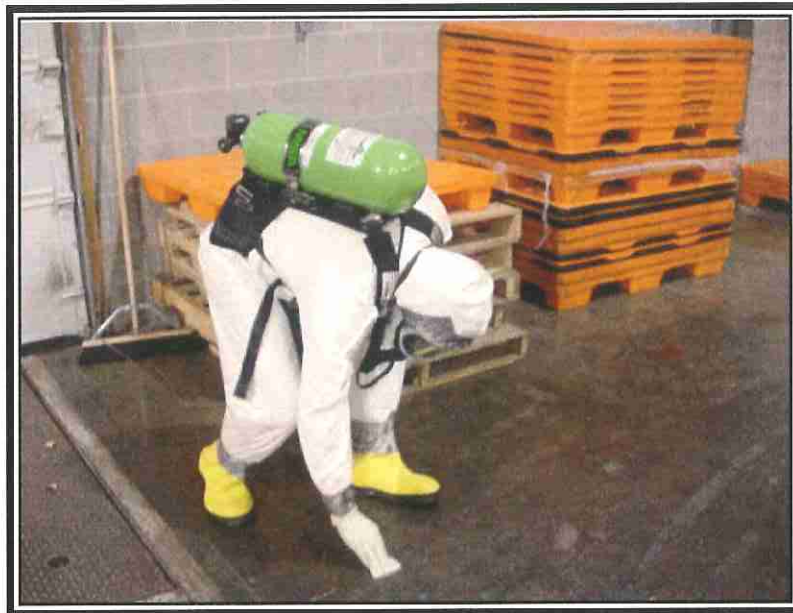
**Photograph No.:** 3  
**TDD Number:** S05-0110-018  
**Location:** DDD Anthrax Facility Site  
**Subject:** View of Tetra Tech START collecting a wipe sample in Building Section G.  
**Orientation:** East  
**Date:** November 1, 2001

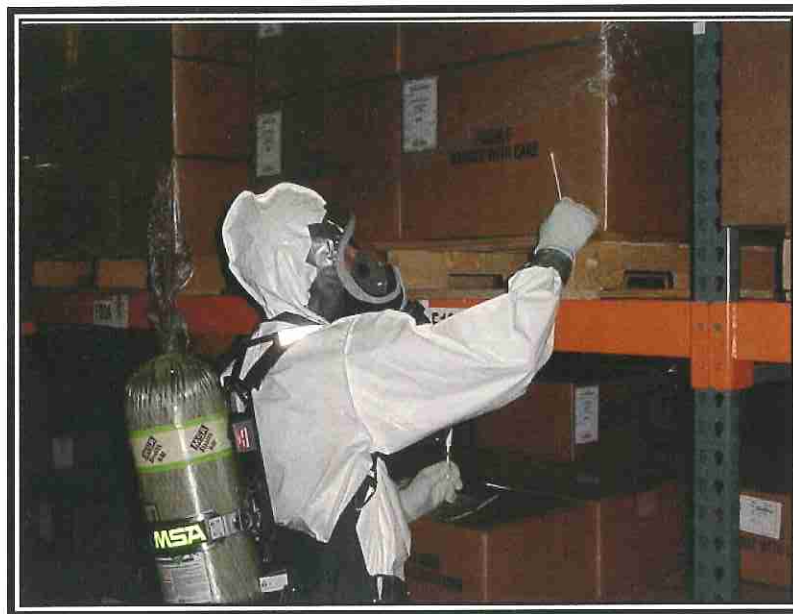
**Photograph No.:** 4  
**TDD Number:** S05-0110-018  
**Location:** DDD Anthrax Facility Site  
**Subject:** View of Tetra Tech START collecting a culture swab sample in Building Section I.  
**Orientation:** East  
**Date:** November 1, 2001

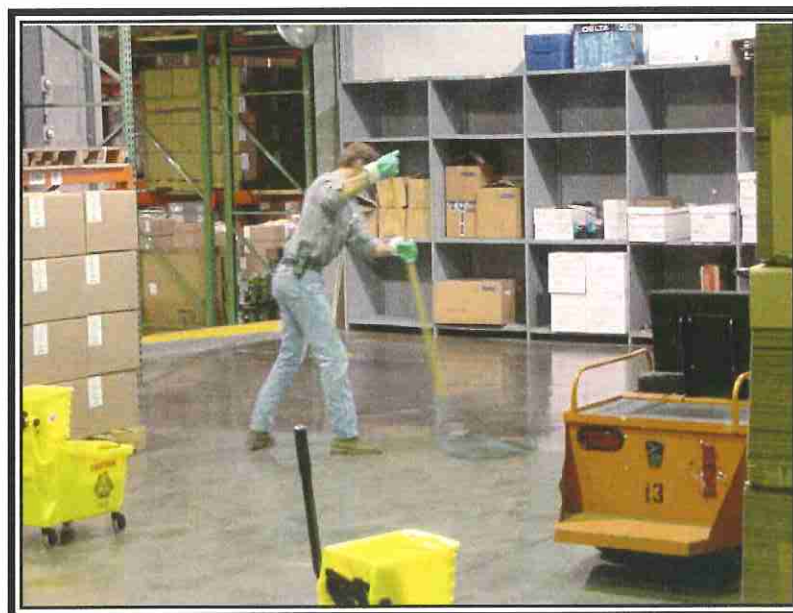
**Photograph No.:** 6  
**TDD Number:** S05-0110-018  
**Location:** DDD Anthrax Facility Site  
**Subject:** View of IT Corporation mopping the floor with a 3 percent bleach solution.

IT and Summit personnel cleaned the southern portion of the DDD facility using a 3 percent bleach solution on the concrete floor and a 5 percent bleach solution on work stations and tabletops (see Photograph No. 6, Appendix A). The personnel decontamination line consisted of four stations: (1) an initial detergent wash and scrub; (2) a 10-minute wash with a 10 percent bleach solution; (3) a 5 percent sodium thiosulfate rinse; and (4) a shower water rinse (see Photograph Nos 7 and 8, Appendix A).

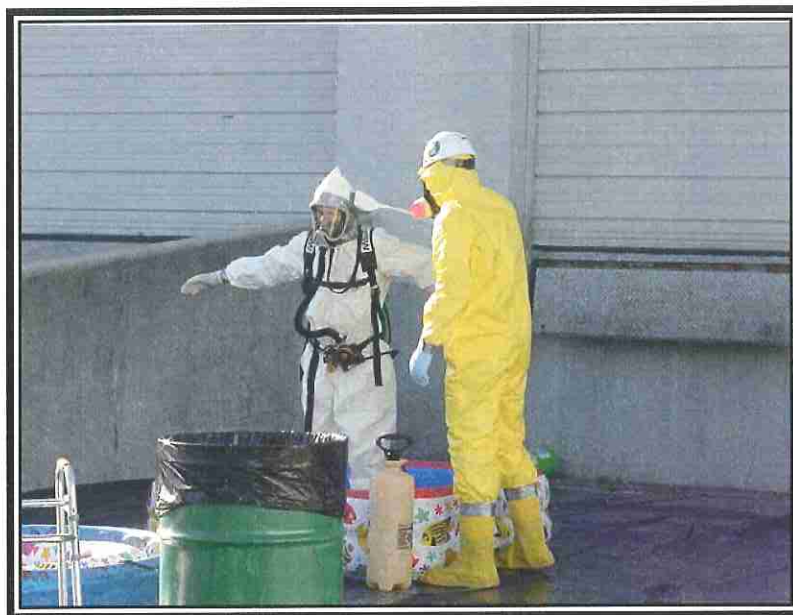
**Photograph No.:** 7  
**TDD Number:** S05-0110-018  
**Location:** DDD Anthrax Facility Site  
**Subject:** View of Summit Environmental Services, Inc., personnel decontaminating a member from the Tetra Tech START sampling team.

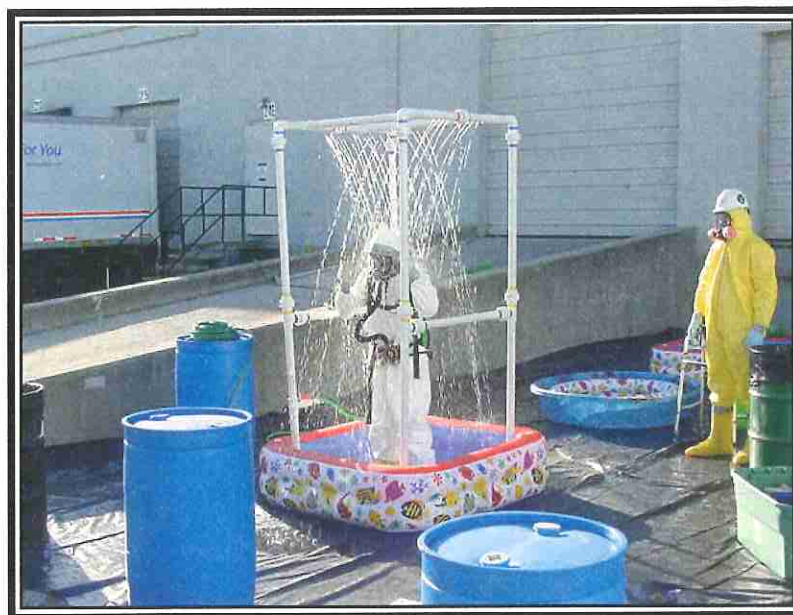
**Photograph No.:** 8  
**TDD Number:** S05-0110-018  
**Location:** DDD Anthrax Facility Site  
**Subject:** View of the decontamination shower.

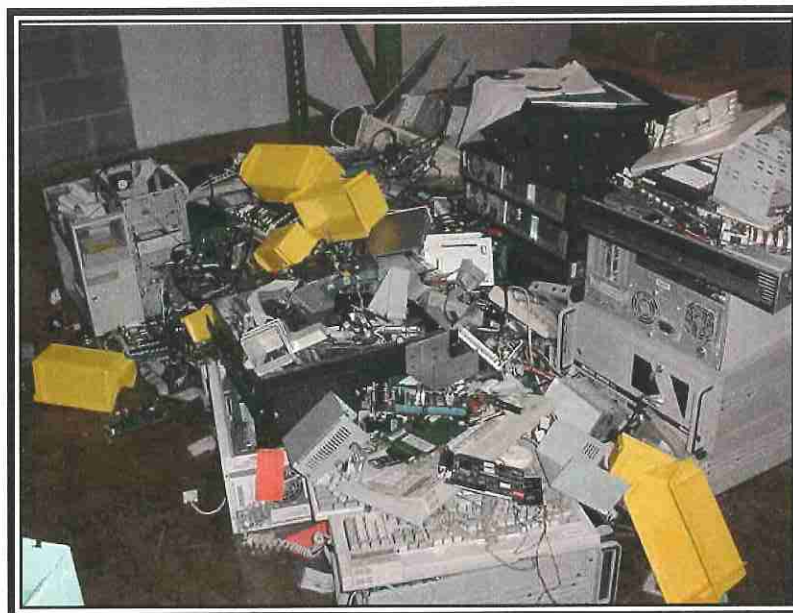
**Photograph No.:** 9  
**TDD Number:** S05-0110-018  
**Location:** DDD Anthrax Facility Site  
**Subject:** View of electronic and computer components identified by the facility that were disposed because of the potential for anthrax contamination.

solution on the concrete floor and a 5 percent bleach solution on work stations and tabletops. As a precautionary measure, USPS made the conservative decision to wash and dispose of all office personal computers and equipment that may or may not have been contaminated with anthrax spores (see Photograph No. 9, Appendix A). Some of the equipment was confirmed by USPS personnel to have been received from contaminated postal service facilities on the east coast. Items such as electrical components, computer boards, and computer screens were immersed into a 5 percent bleach solution bath for 10 minutes and then placed on a drying line (see Photograph Nos 10 through 12, Appendix A) by IT personnel. The items were then staged into a plastic-lined box trailer for off-site disposal. Items believed to have originated from east coast post offices were double-bagged and staged into the semitruck box trailer.

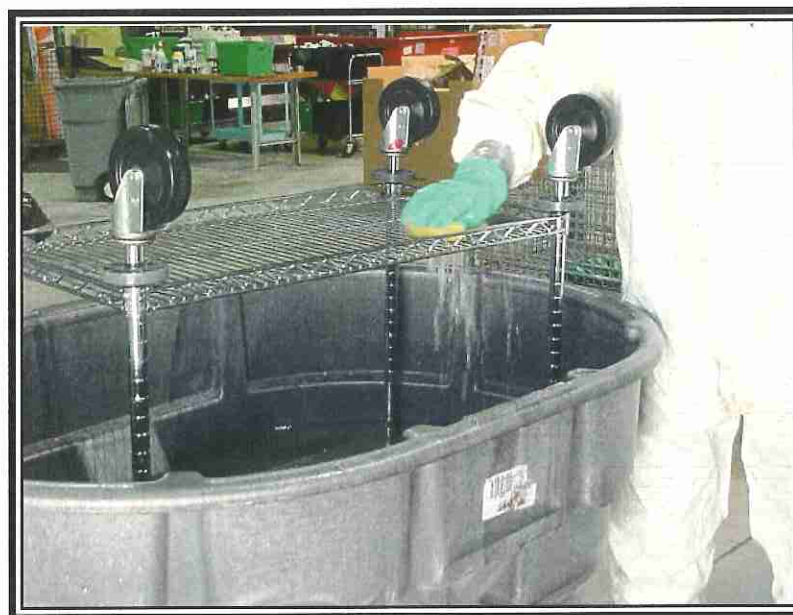
**Photograph No.:** 10  
**TDD Number:** S05-0110-018  
**Location:** DDD Anthrax Facility Site  
**Subject:** View of IT Corporation personnel decontaminating facility items in a bleach solution.

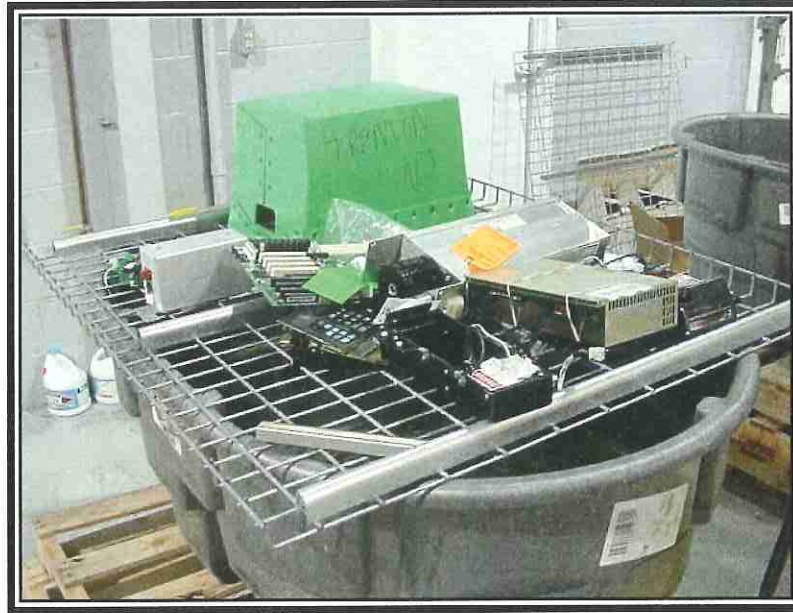
**Photograph No.:**

View of decontaminated items placed on the drip line.

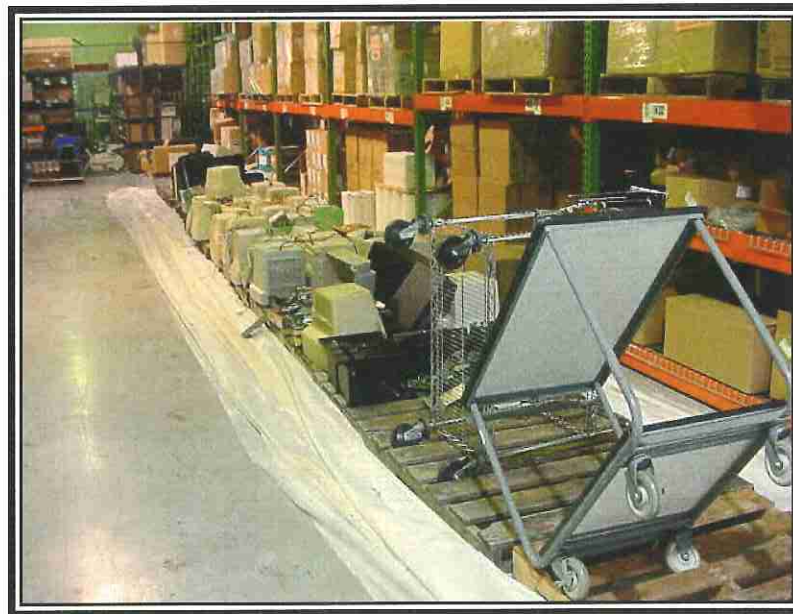
**Photograph No.:**

View of decontaminated items on the drying line. These items were saved by the facility and not disposed of off site.

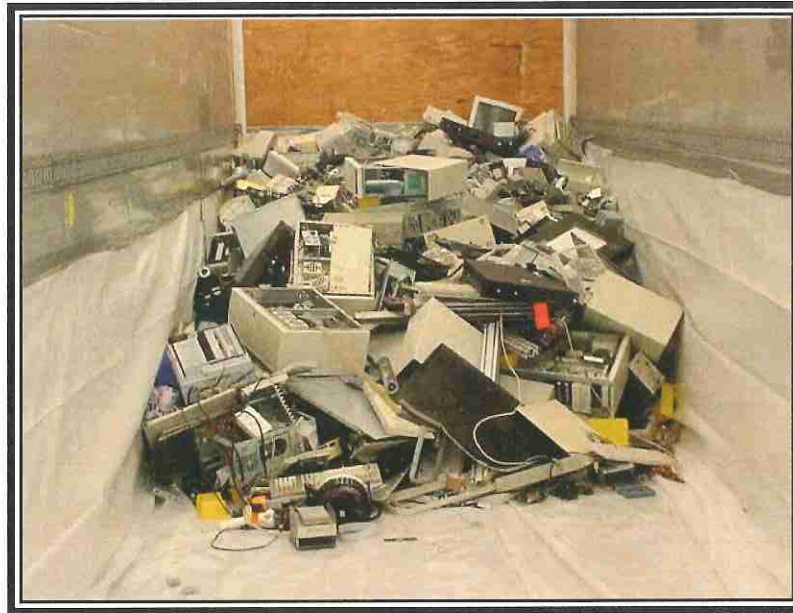
**Photograph No.:** 13  
**TDD Number:** S05-0110-018  
**Location:** DDD Anthrax Facility Site  
**Subject:** View of decontaminated items staged in box truck prior to off-site disposal.

IT personnel completed decontaminating the northern portion of the DDD facility using a 3 percent bleach solution on the concrete floor and a 5 percent bleach solution on the work stations and tabletops. In addition, IT personnel completed washing, in a 5 percent bleach solution, computer boards, computer screens, electrical components, and other equipment, as determined by USPS personnel. All items identified by USPS personnel as requiring washing and disposal were staged into a plastic-lined box trailer for off-site disposal (see Photograph No. 13, Appendix A).

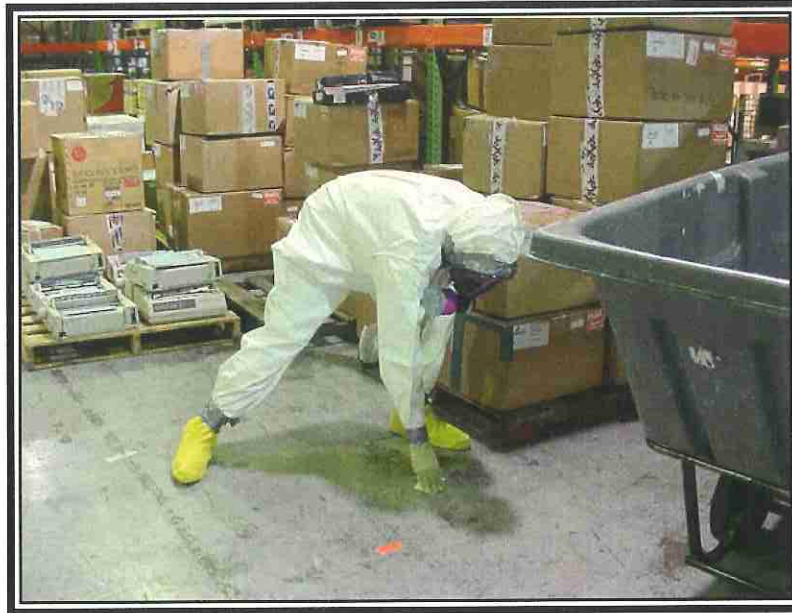
**Photograph No.:** 15  
**TDD Number:** S05-0110-018  
**Location:** DDD Anthrax Facility Site  
**Subject:** View of Tetra Tech START collecting a postdecontamination floor wipe sample.

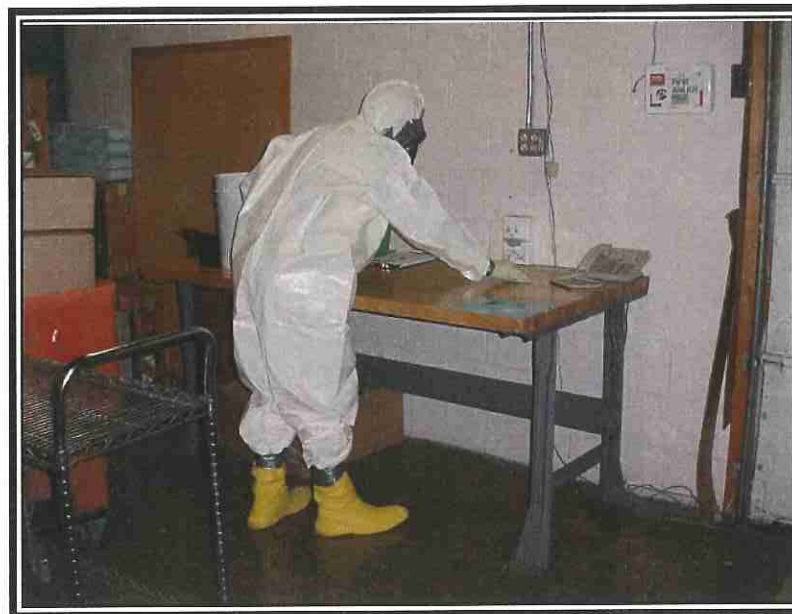
**Photograph No.:** 16  
**TDD Number:** S05-0110-018  
**Location:** DDD Anthrax Facility Site  
**Subject:** View of Tetra Tech START collecting a postdecontamination wipe sample from a work bench.

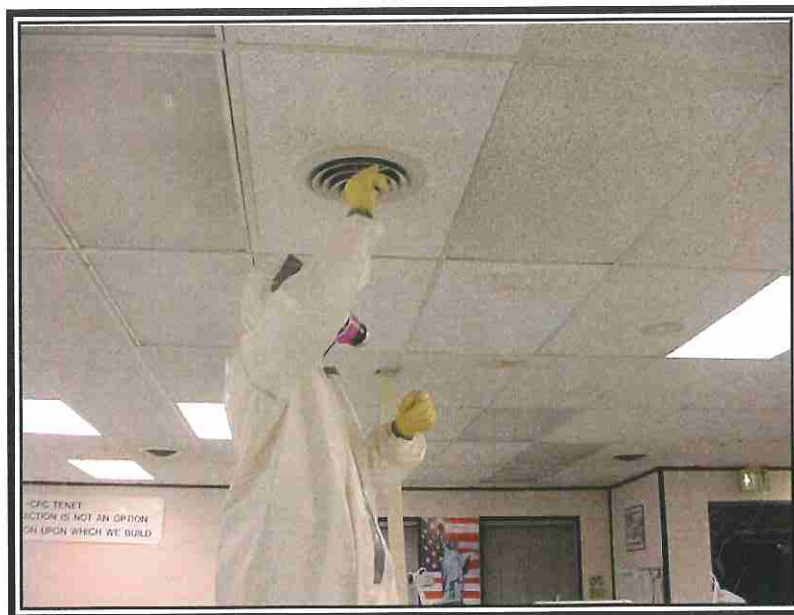
**Photograph No.:** 17  
**TDD Number:** S05-0110-018  
**Location:** DDD Anthrax Facility Site  
**Subject:** View of Tetra Tech START collecting a postdecontamination swab sample from a heating and air conditioning vent.  
**Orientation:** Interior  
**Date:** November 7, 2001

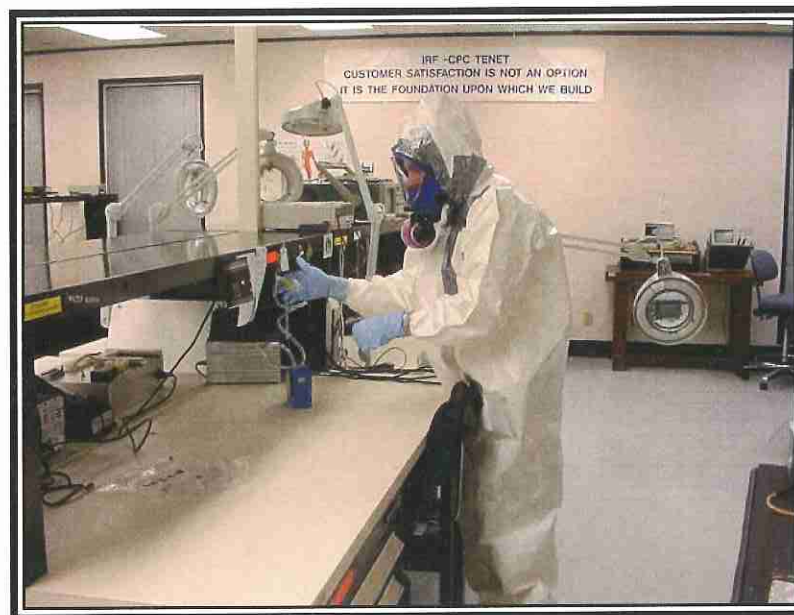
**Photograph No.:** 18  
**TDD Number:** S05-0110-018  
**Location:** DDD Anthrax Facility Site  
**Subject:** View of Tetra Tech START setting up a postdecontamination air sample.  
**Orientation:** West  
**Date:** November 7, 2001
